Paper name: **Development of a New Refractory Repair Technology in Hot Blast Stove in pressurized condition at SAIL-IISCO Steel Plant**

SAIL-IISCO STEEL PLANT

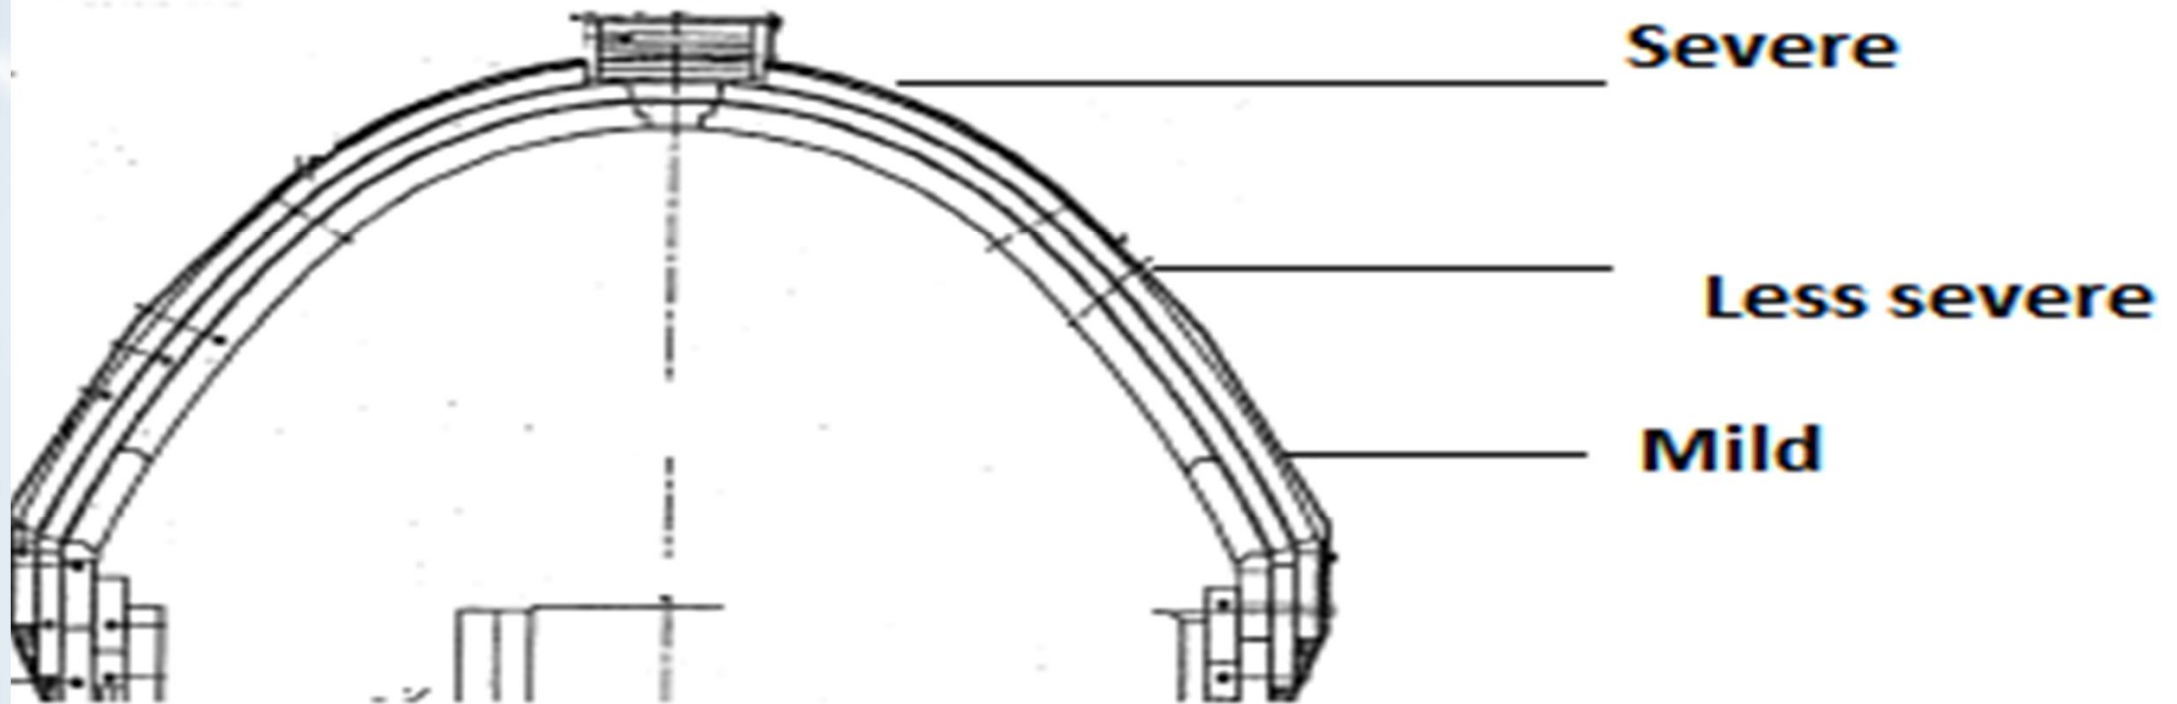
LOCATION AND SEVERITY OF HOT SPOTS IN DOME AREA

- The stove were commissioned in November, 2014 along with the furnace,
- Within 4 years of operations, development of hot spots on shell of stove dome started. Nos. of hot spots gradually increased with the passage of time and domes of all the stoves, hot blast main and bustle main were affected.
- Shell temperature of stove#1 crossed 400 °c and water spray was introduced to cool the shell.
- Repair by injection done by the OEM in January 2020 and August 2021 but hot spots appeared again after 4 to 5 months and water spray on shell was restarted. Prolonged water spray was affecting the shell. Cost and timely availability of the service by OEM is not favourable.
- A repair technique has been developed by ISP using materials, machines and tools make in India. Repair by injection was carried out in June 2022.

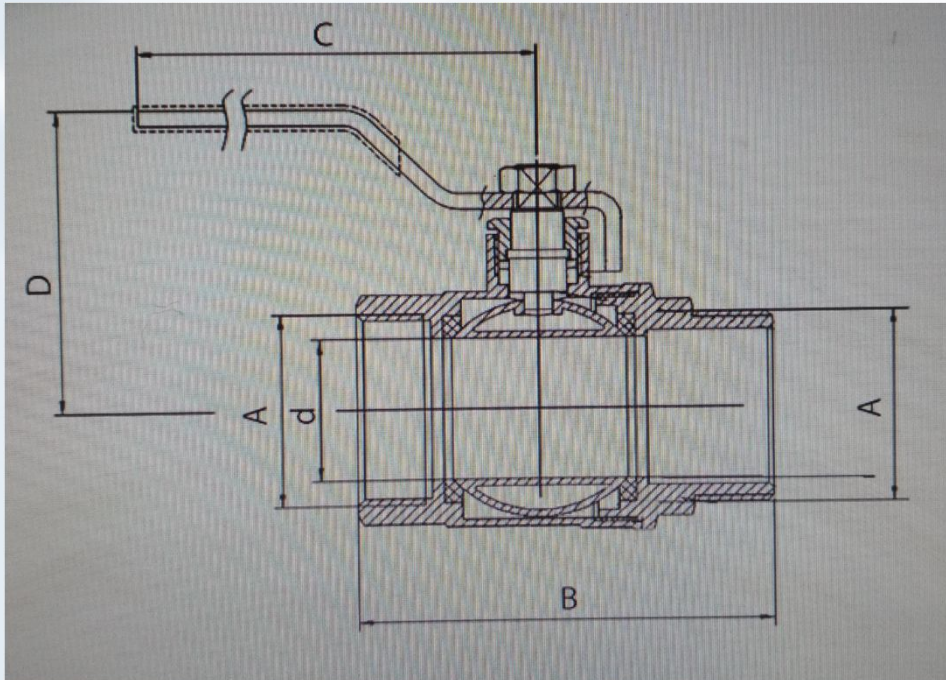
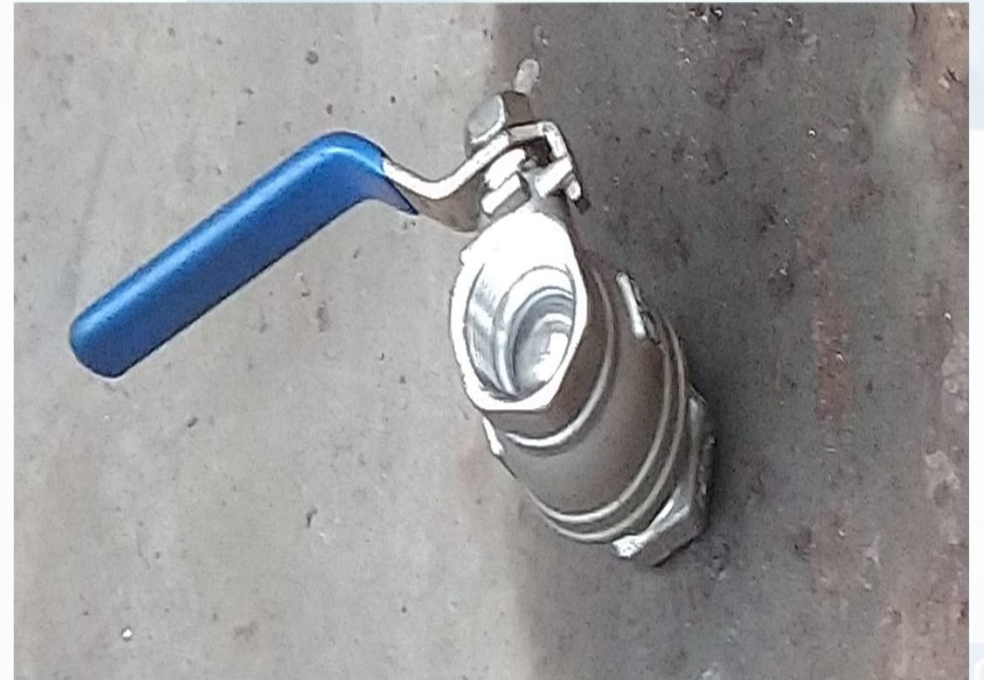
USE OF VALVE ALONG WITH THE NOZZLE TO STOP COMING OUT OF HOT GAS

- During shut down of the blast furnace, repair of the HBM and BM areas were carried out by cutting of shell or injection of mortars by welding nozzles on the shell by conventional repair methods. Draft created in Back-draft chimney ensures negative pressure in these areas.
- But at the dome, very difficult to create sufficient draft because of quite high temperature inside stoves compared to chimney.
- Hot gas comes out if any opening is created in the dome area.

- Nozzles and valves fixed by partial drilling and tapping of the shell
- Final drilling done through the valve
- Pumping done at 4 to 5 kg/cm² pressure
- After pumping, valve removed and nozzles were capped.

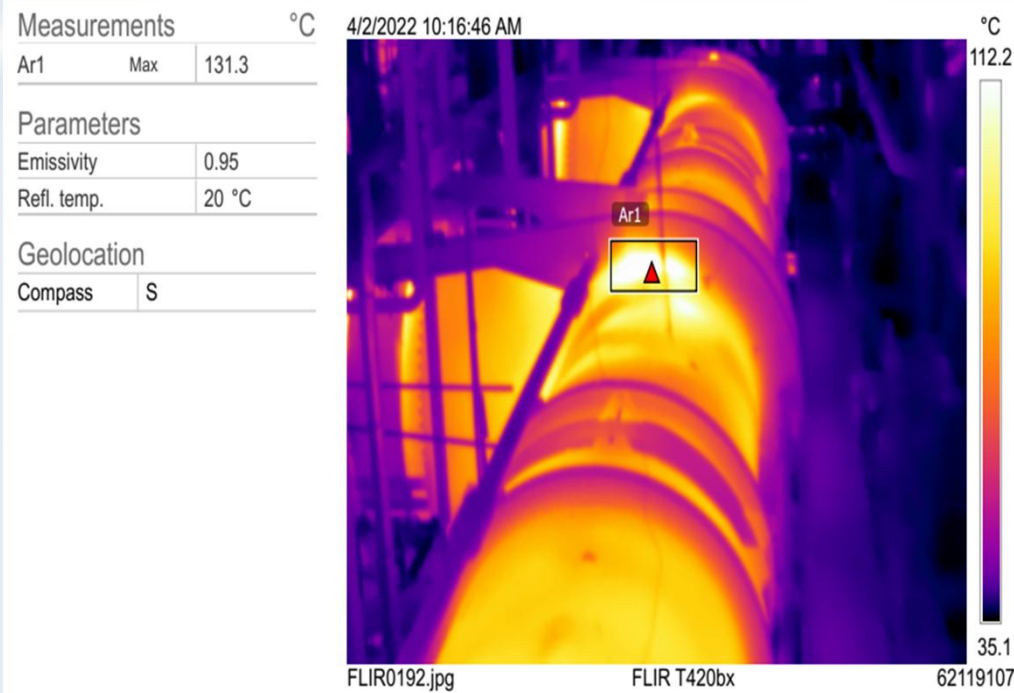
Before Injection

COMPARATIVE THERMOGRAPHY OF HOT BLAST MAIN AREA

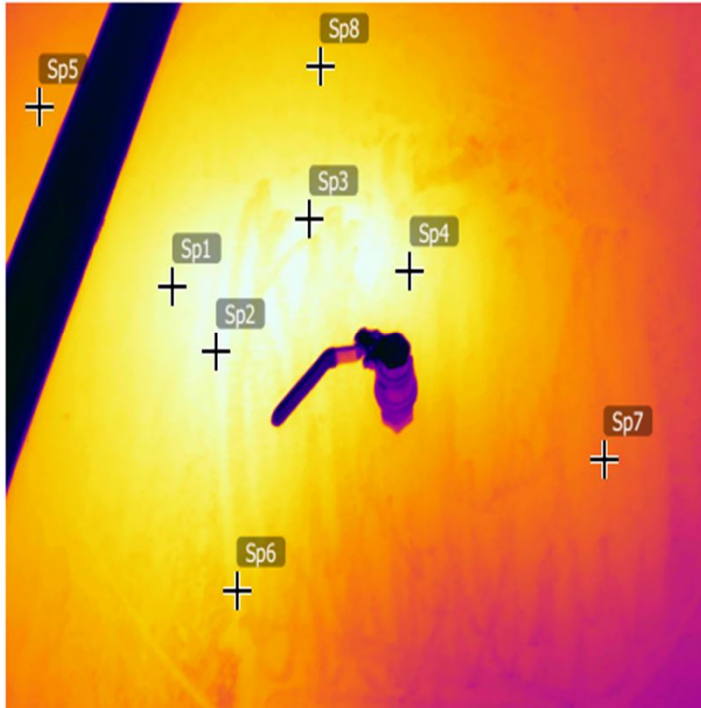
Before Injection

THERMOGRAPH OF A HOT SPOT AT STOVE#1 DOME

Sp1	184.9 °C
Sp2	185.9 °C
Sp3	186.7 °C
Sp4	184.3 °C
Sp5	163.9 °C
Sp6	172.7 °C
Sp7	156.6 °C
Sp8	173.7 °C

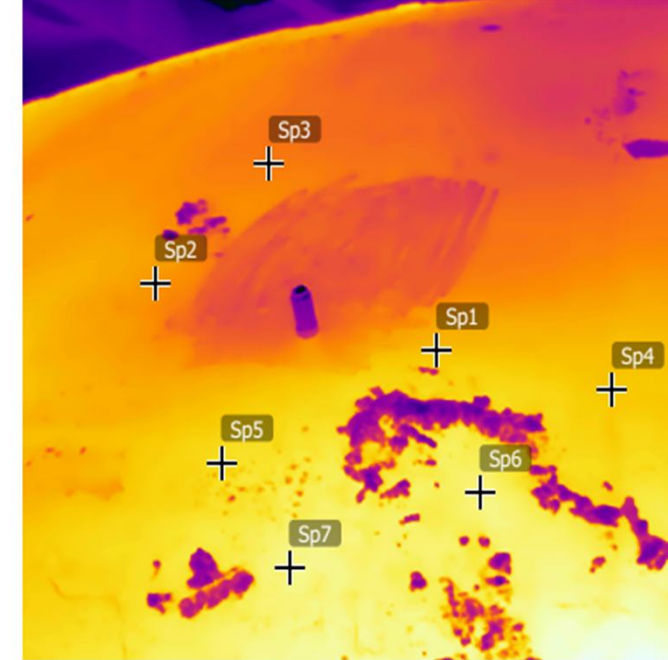
After Injection

Sp1	94.5 °C
Sp2	92.5 °C
Sp3	91.2 °C
Sp4	94.9 °C
Sp5	95.7 °C
Sp6	98.6 °C
Sp7	98.8 °C

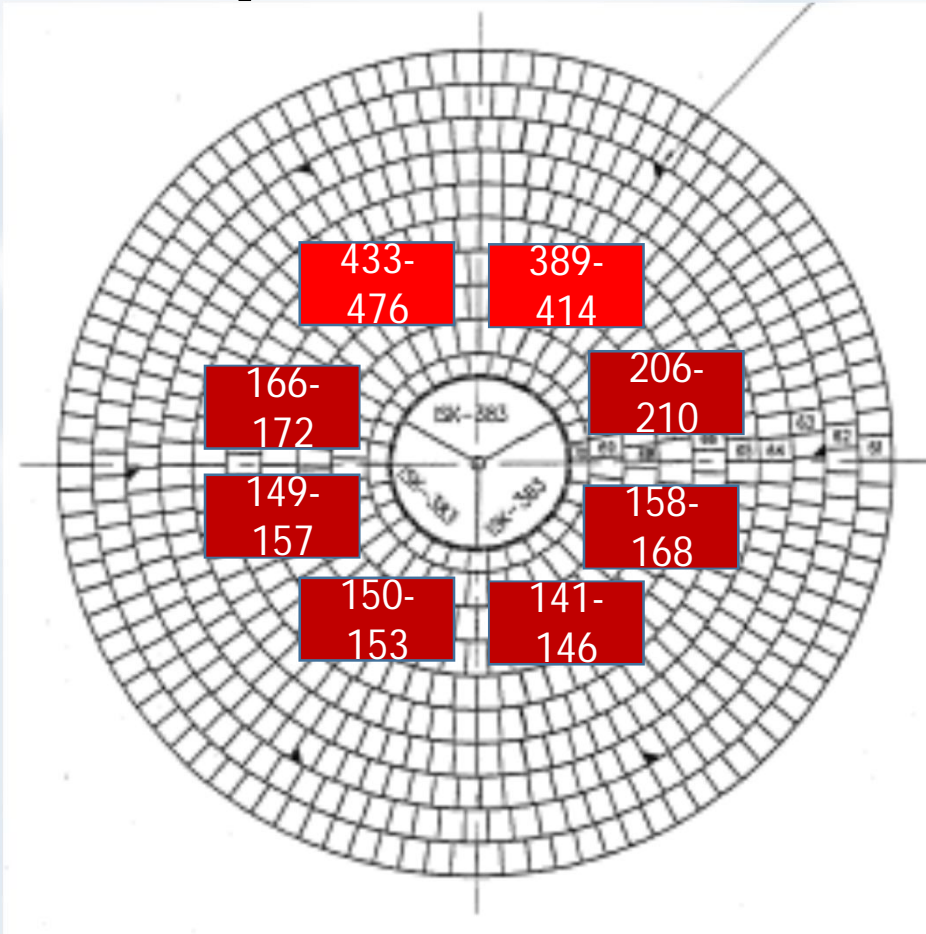
Before Injection

SHELL TEMPERATURES ON HOT SPOTS AT SEVERE ZONE OF STOVE#1 DOME
