# Bottom Purging Improvement of Steel Ladle at LD#3 (TSL JSR)

**Tata Steel Limited**

## Background:

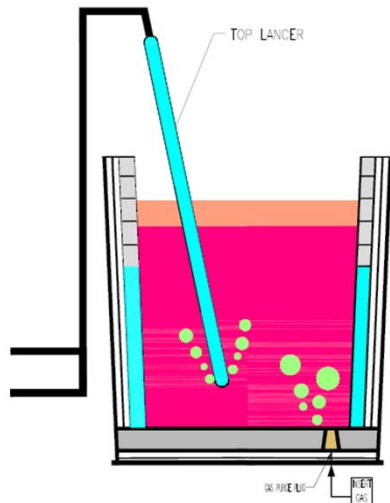
The LF( ladle Furnace ) comes with top lance and one or more Porous Plug at ladle bottom

Fig 1: Schematic diagram of ladle with purging arrangements

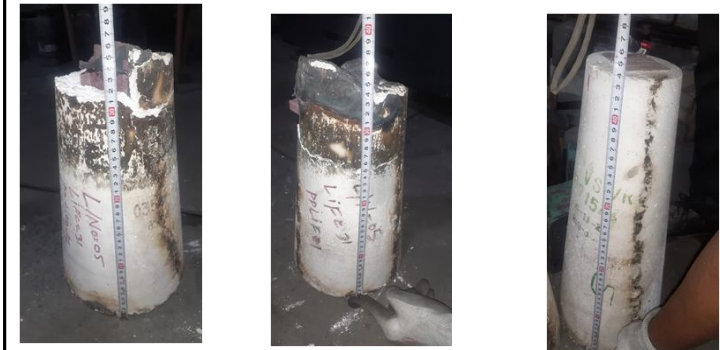
We have investigated the erosion pattern of few used plugs after certain lifetime & found safe remnant length in most of the cases as shown in Fig 4. Metal penetration was also measured at the same time

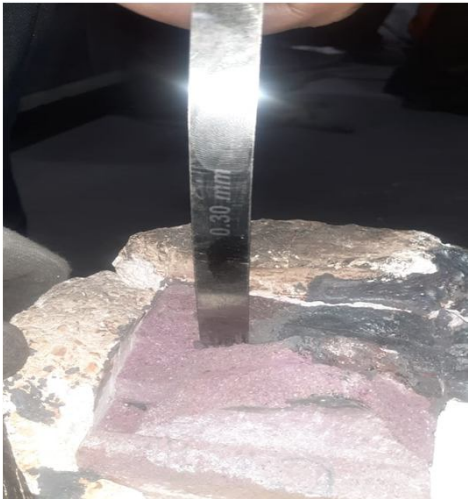
*e) Gaps in between Segments:*

Segment gap beyond specified norms may lead steel infiltration in between segment slits. Gaps may also occur due to various phase changes of refractory at higher temperature which may lead to shrinkage.
