# ADVANCEMENTS IN REFRACTORY MAINTENANCE PRACTICES IN RINL – VISAKHAPATNAM STEEL PLANT

- Sandipan Roy, Sr. Mgr. (RED)
- Pratik Priyank, Mgr. (RED)

# Major technological Modifications

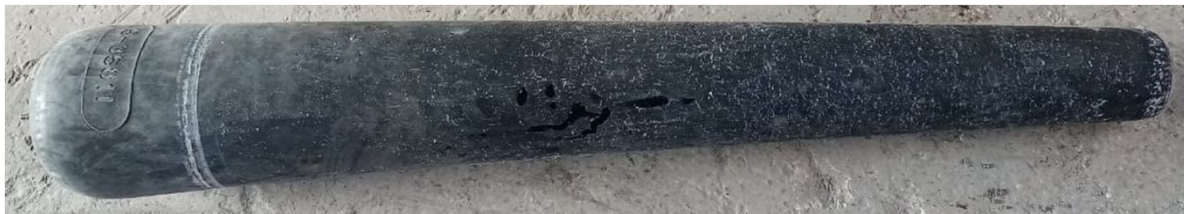
## BLOWPIPE MOULD

- ▶ Chrome based alumina self flow castable was used for casting
- ▶ Rubber moulds were used instead of paper moulds

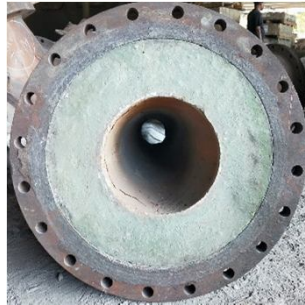
- ▶ Composition change did not enhance the life as expected

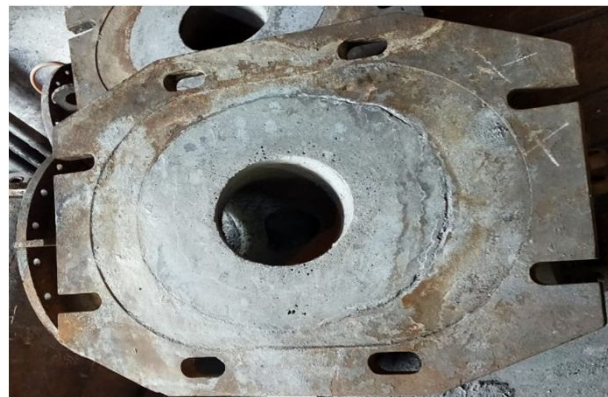
- ▶ Rubber moulds showed better results in downleg and blowpipes casting
- ▶ But many elbows were off centered, due to rubber moulds

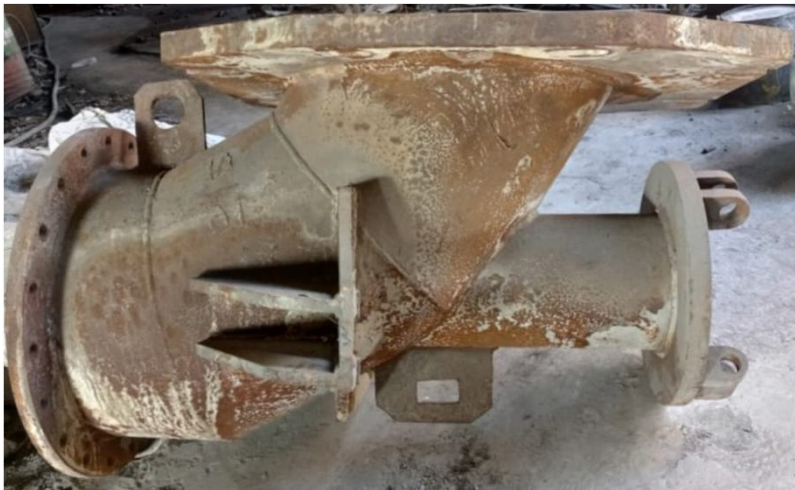
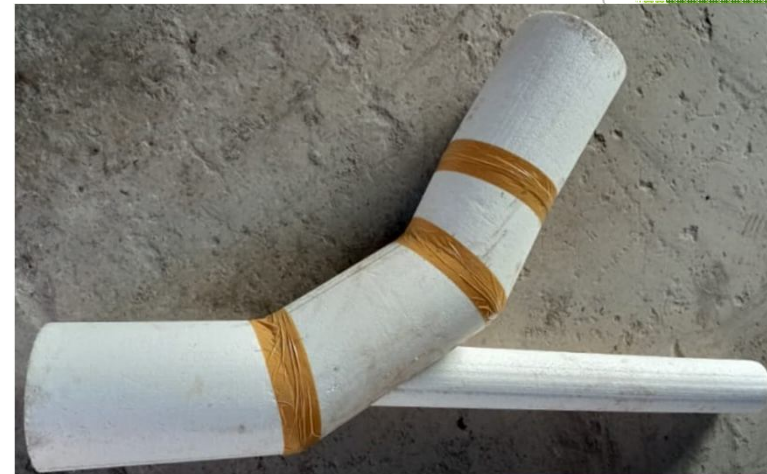
- ▶ 60% alumina based self flow castable was used for casting
- ▶ Thermocol moulds were used for elbow casting

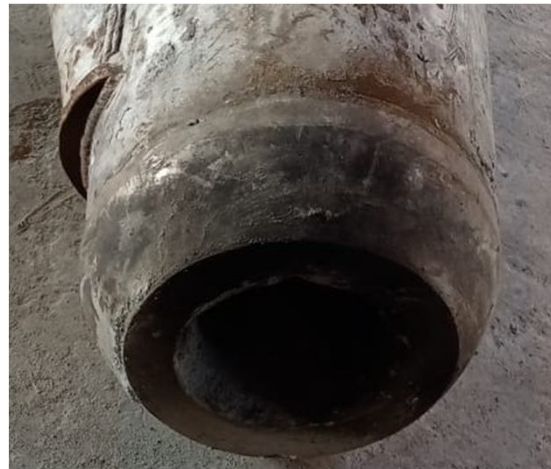
- ▶ Composition change enhanced the performance of tuyere stock assembly
- ▶ Thermocol moulds resolved the off centering issue in elbow casting
- ▶ However, the narrow end tip of blowpipe sometimes developed red spot

- ▶ Heavy vibrations were observed in PCI lance during operation

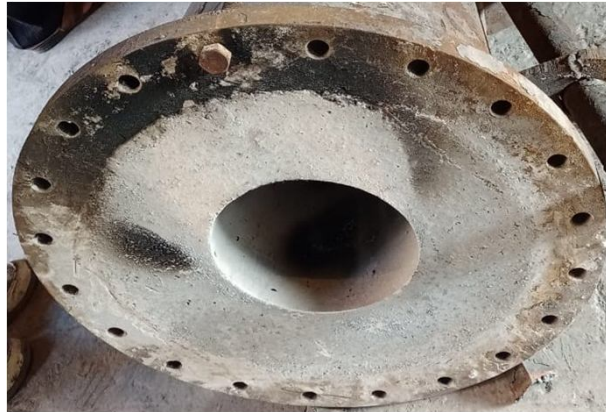
- ▶ Casting thickness of blowpipes was increased by 10mm

- ▶ Increasing the casting thickness eliminated the occurrence of red spots
- ▶ PCI pipe displayed less vibrations thereby improving life of blowpipes
- ▶ No abnormalities have occurred in the tuyere stock assembly since then

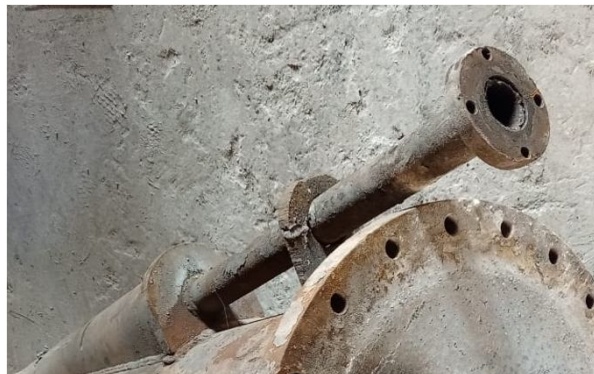
- ▶ Diameter of PCI holding vent in blowpipes was reduced

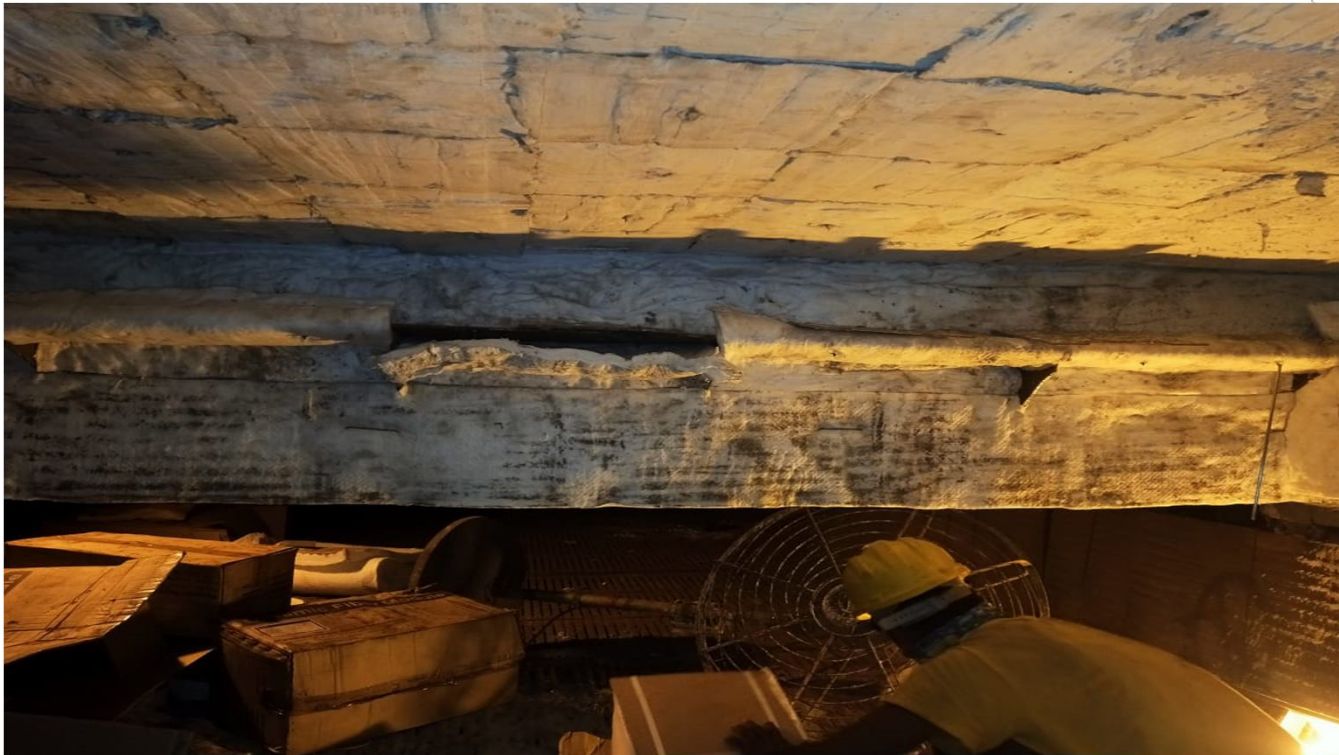
- ▶ As per OEM design, it was lined with ceramic modules
- ▶ However the end wall frequently got damaged and required repair often

- ▶ Castable patching was done on the inner side of end wall to increase longevity but to no avail

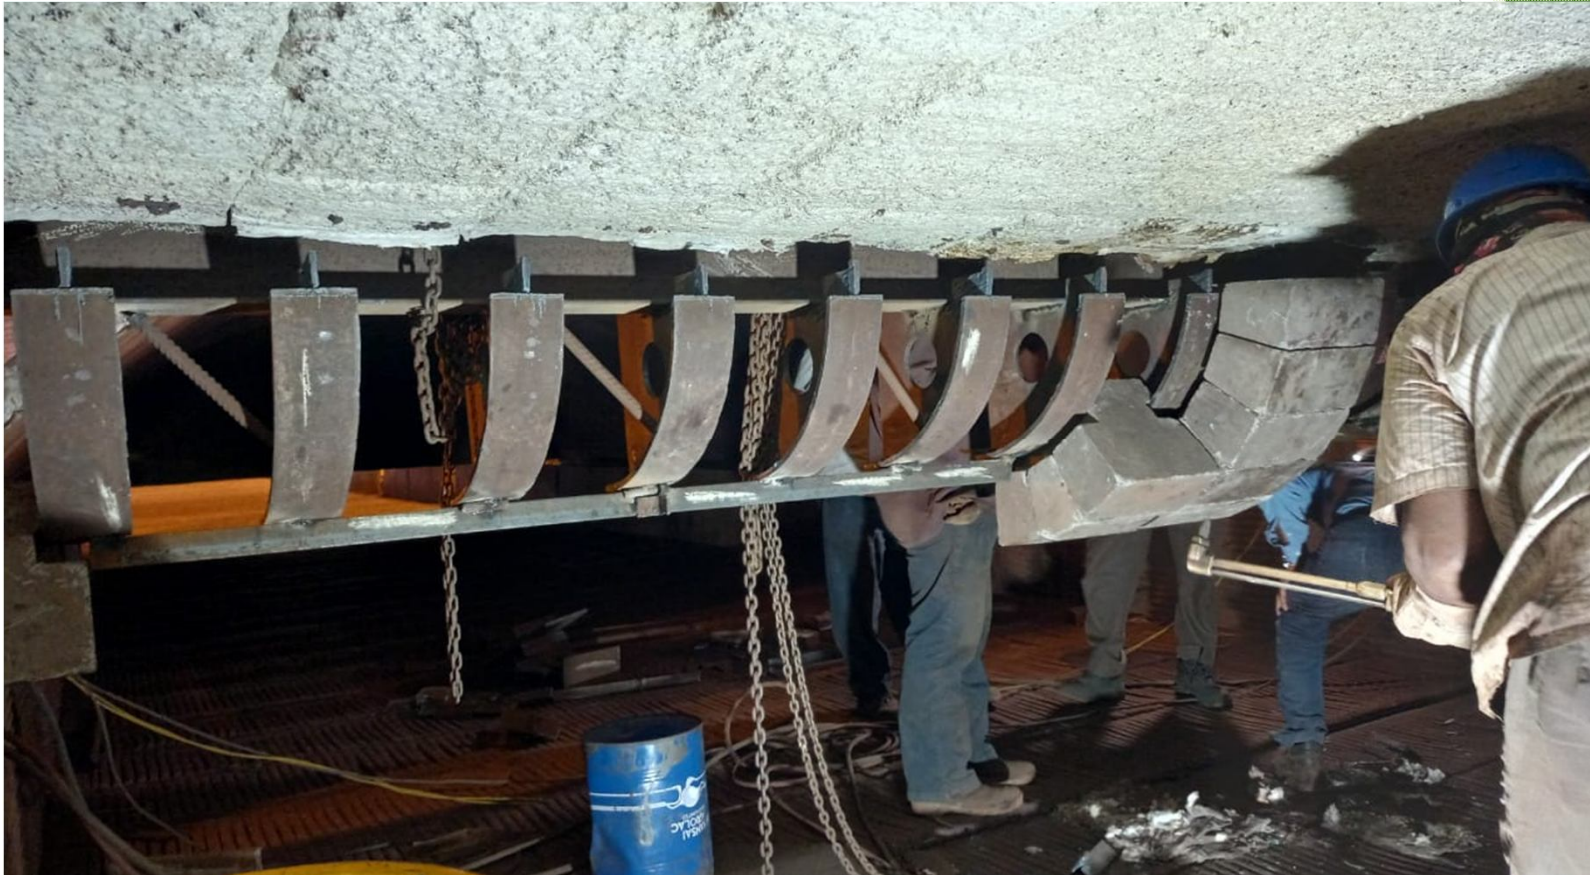
- ▶ It was proposed to install bull nose at the end wall
- ▶ The beam to support bull nose was prepared and tested

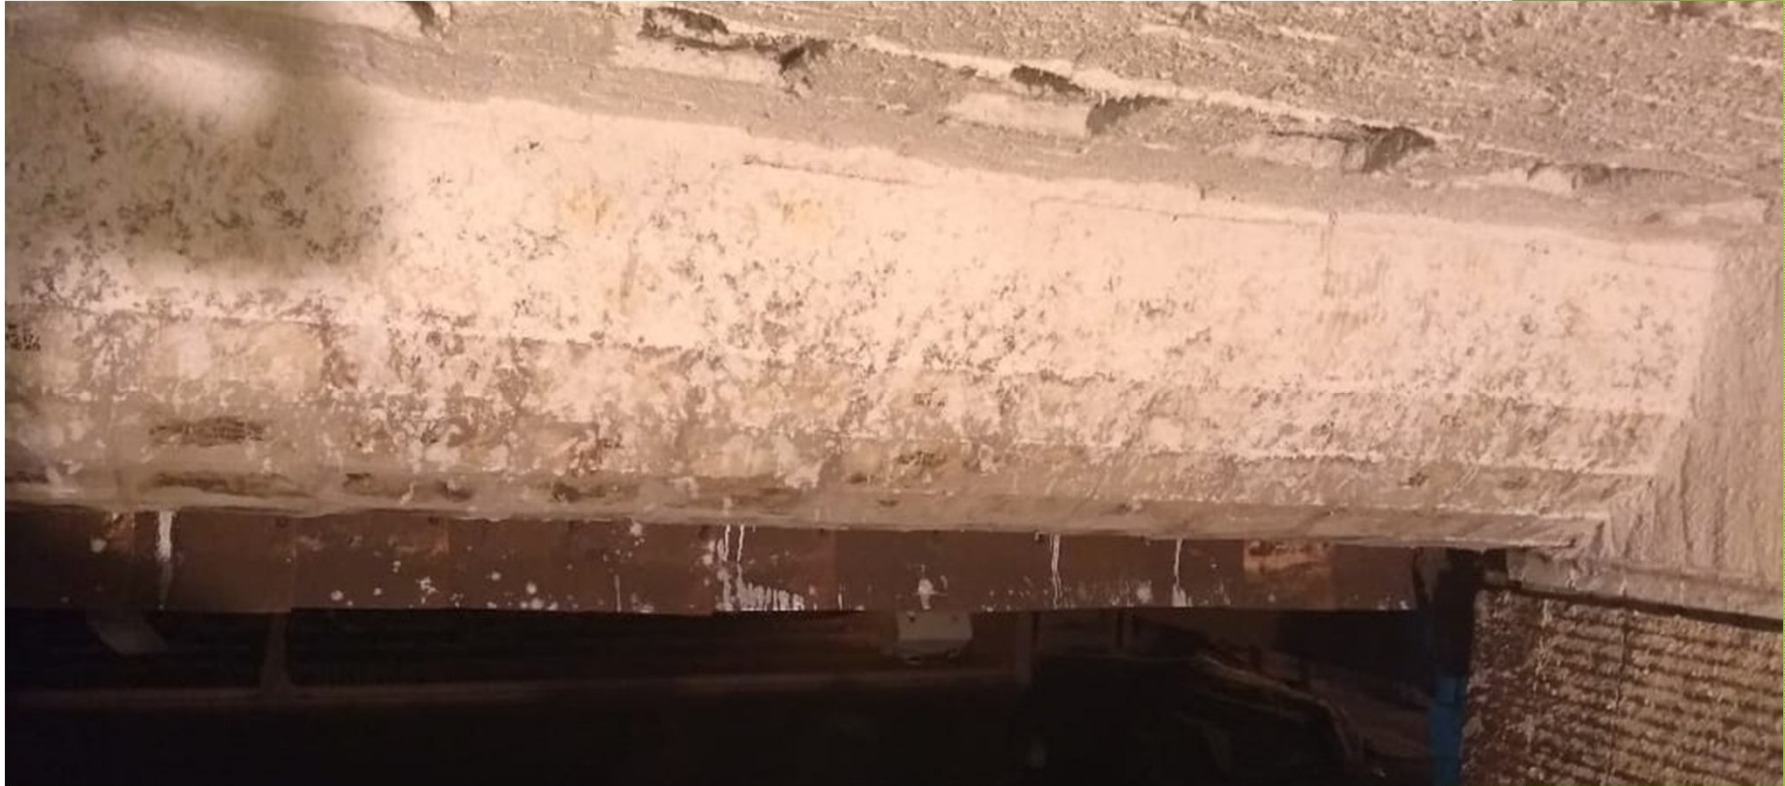
- ▶ The beam was installed at the end wall and bull nose lining was done

- ▶ The performance of the bull nose is on a par with expectations

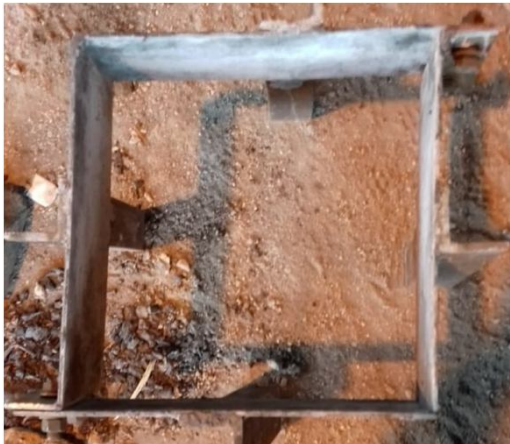
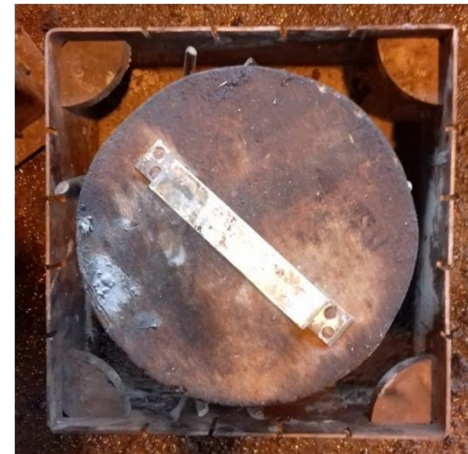
- ▶ The burner blocks provided by Sinter Machine-1 OEM often developed cracks even before installation
- ▶ To avoid any shortage of blocks, it was planned to prepare burner blocks with in-house resources
- ▶ Iron frame for casting was prepared

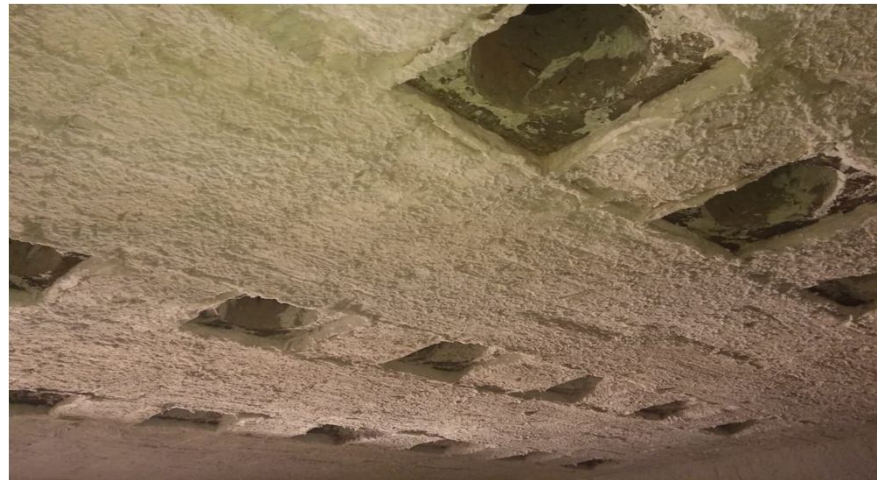
- ▶ These blocks did not develop any cracks over long period of time
- ▶ The burner blocks were installed in Sinter machine -1 roof

- ▶ After prolonged use it was observed that the indigenously prepared burner blocks had a better performance than the OEMs

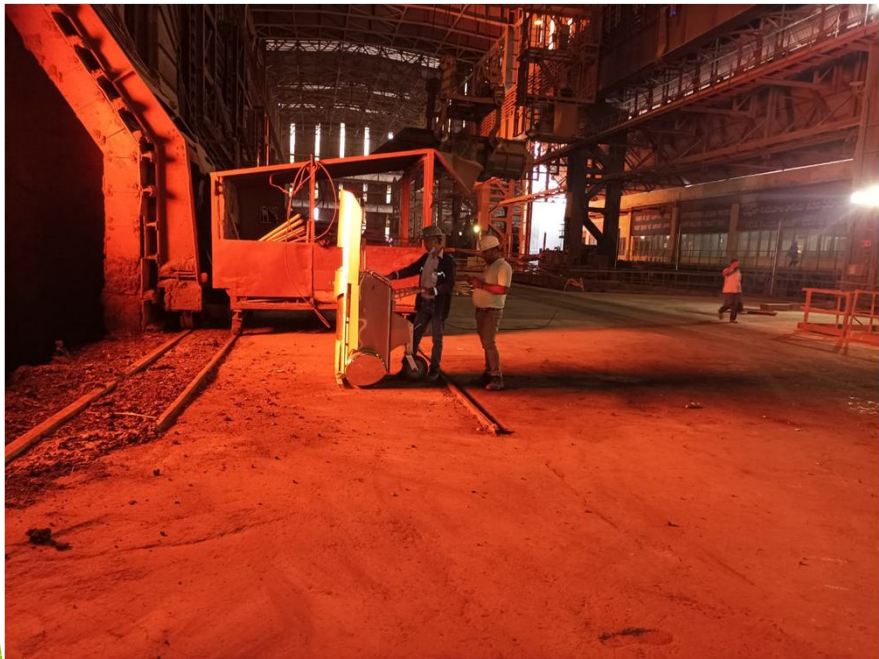
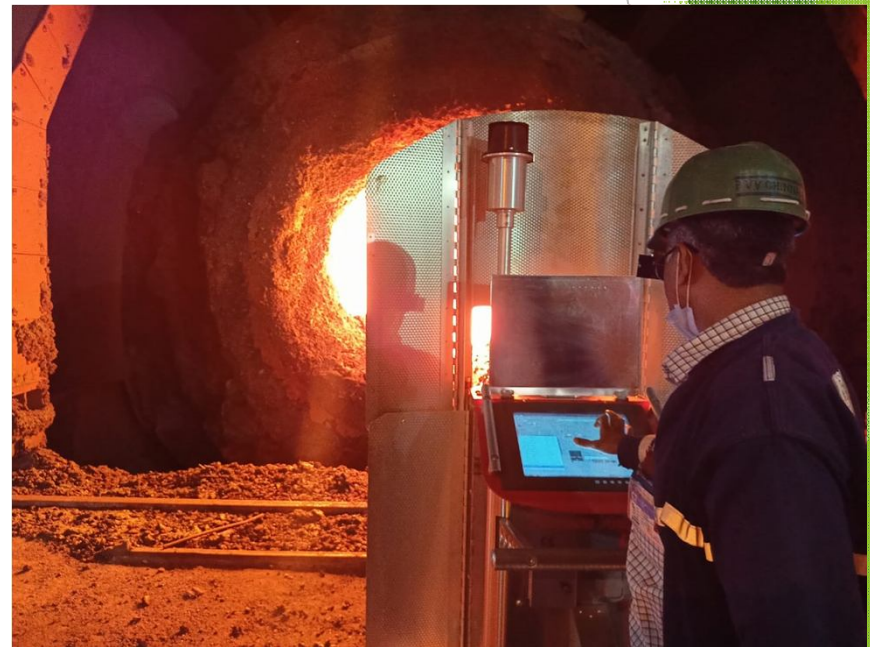
- ▶ Manual inspection of LD Converters sometimes lead to incorrect assessment of converter health
- ▶ For effective inspection of converters, thermal scanning was introduced

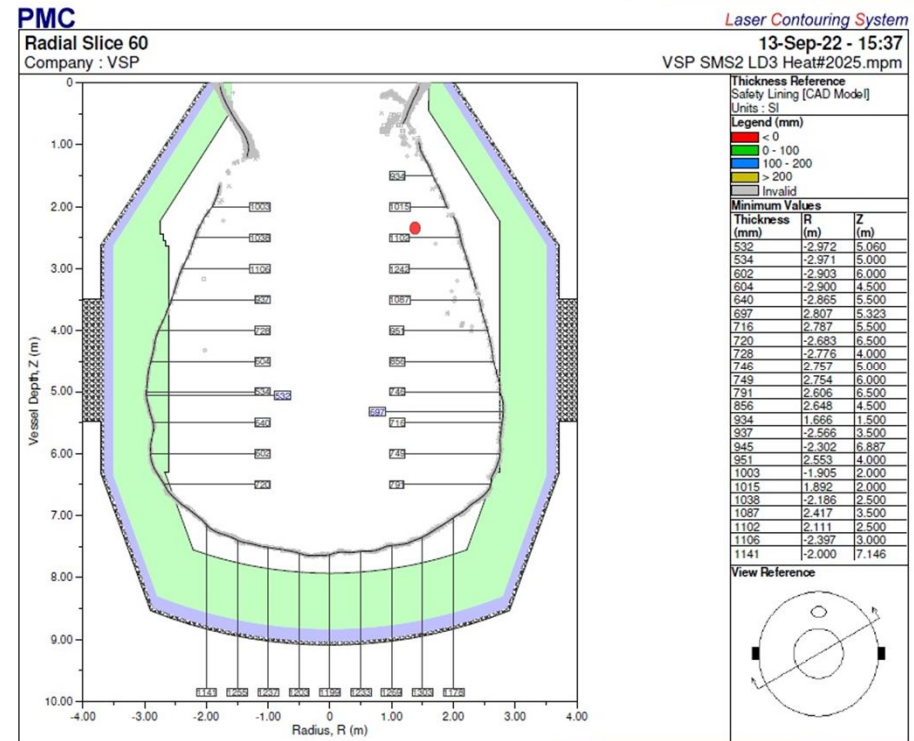
- ▶ Detailed refractory leftover thickness is measured and displayed

- ▶ Accurate refractory thickness data helped in better analyzing the health of refractory lining in converter and steel ladle
- ▶ Effectiveness of various maintenance practices could be easily verified
- ▶ Better life predictions were possible in steel ladle
- ▶ More effective refractory maintenance practice were developed in converters

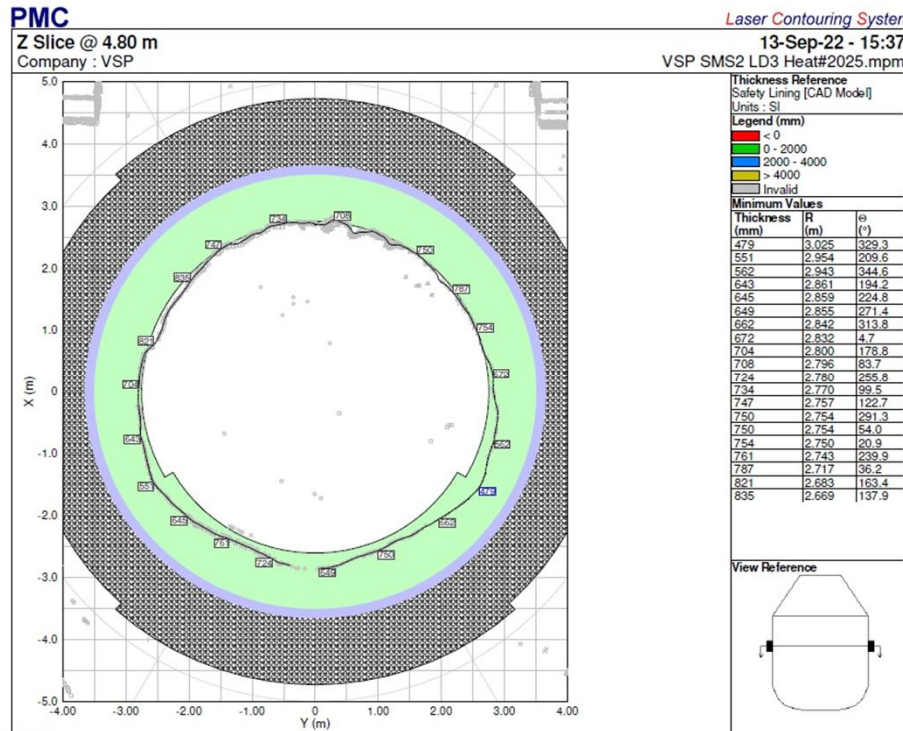
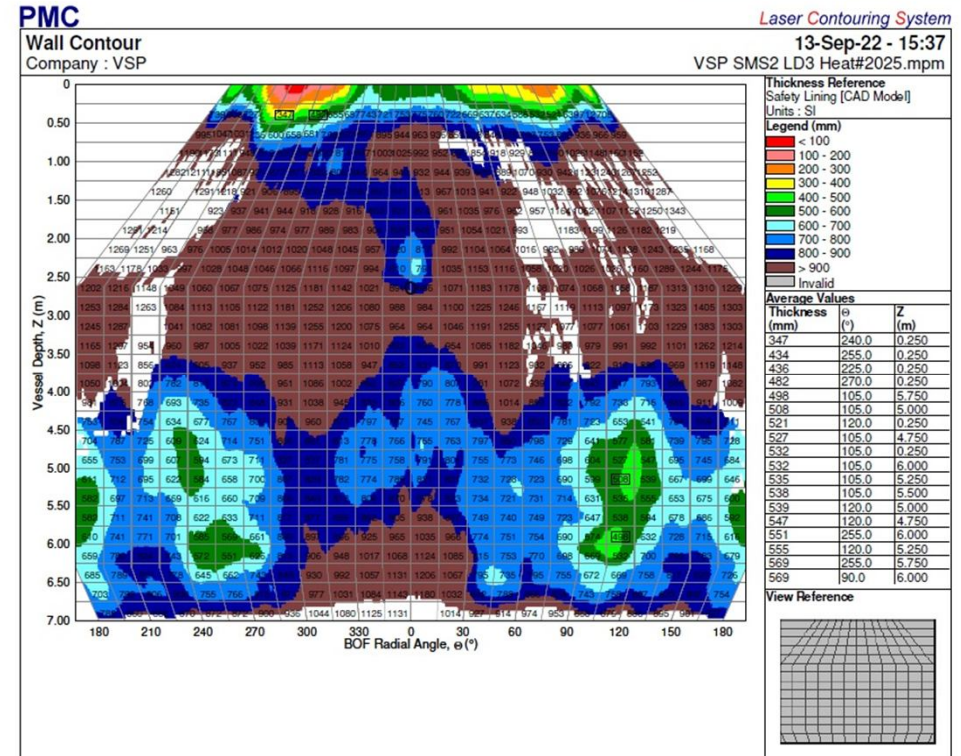
- ▶ Detailed refractory leftover thickness is measured and displayed

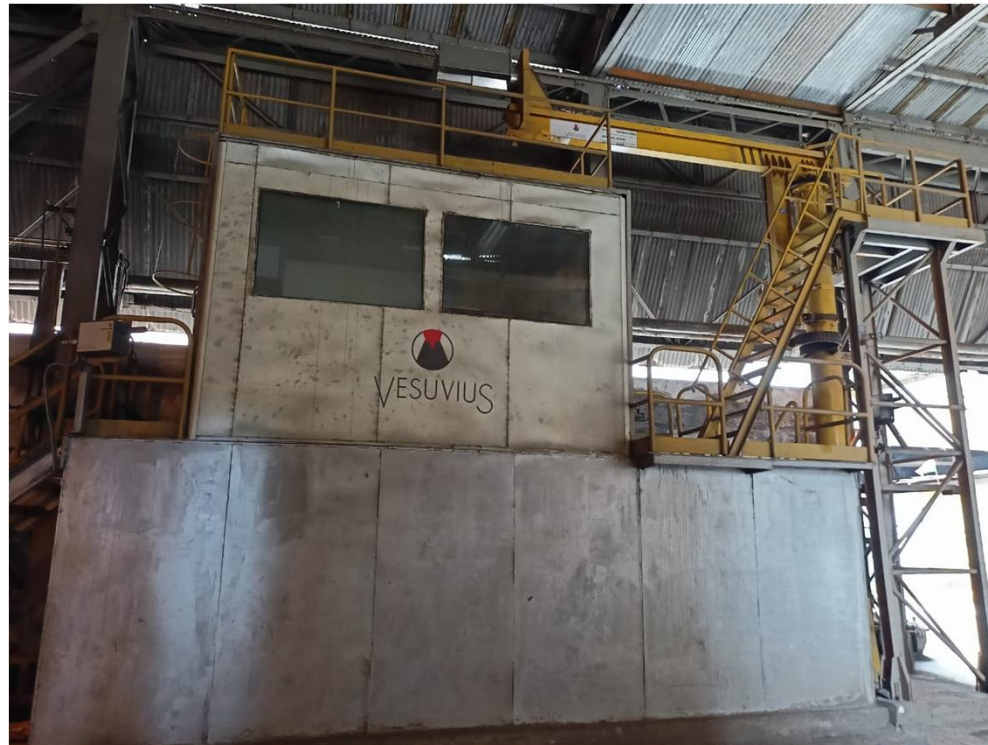
- ▶ Life prediction of steel ladles based on manual inspection were often incorrect
- ▶ To get an accurate idea of refractory condition in ladles, thermal scanning was introduced in steel ladles

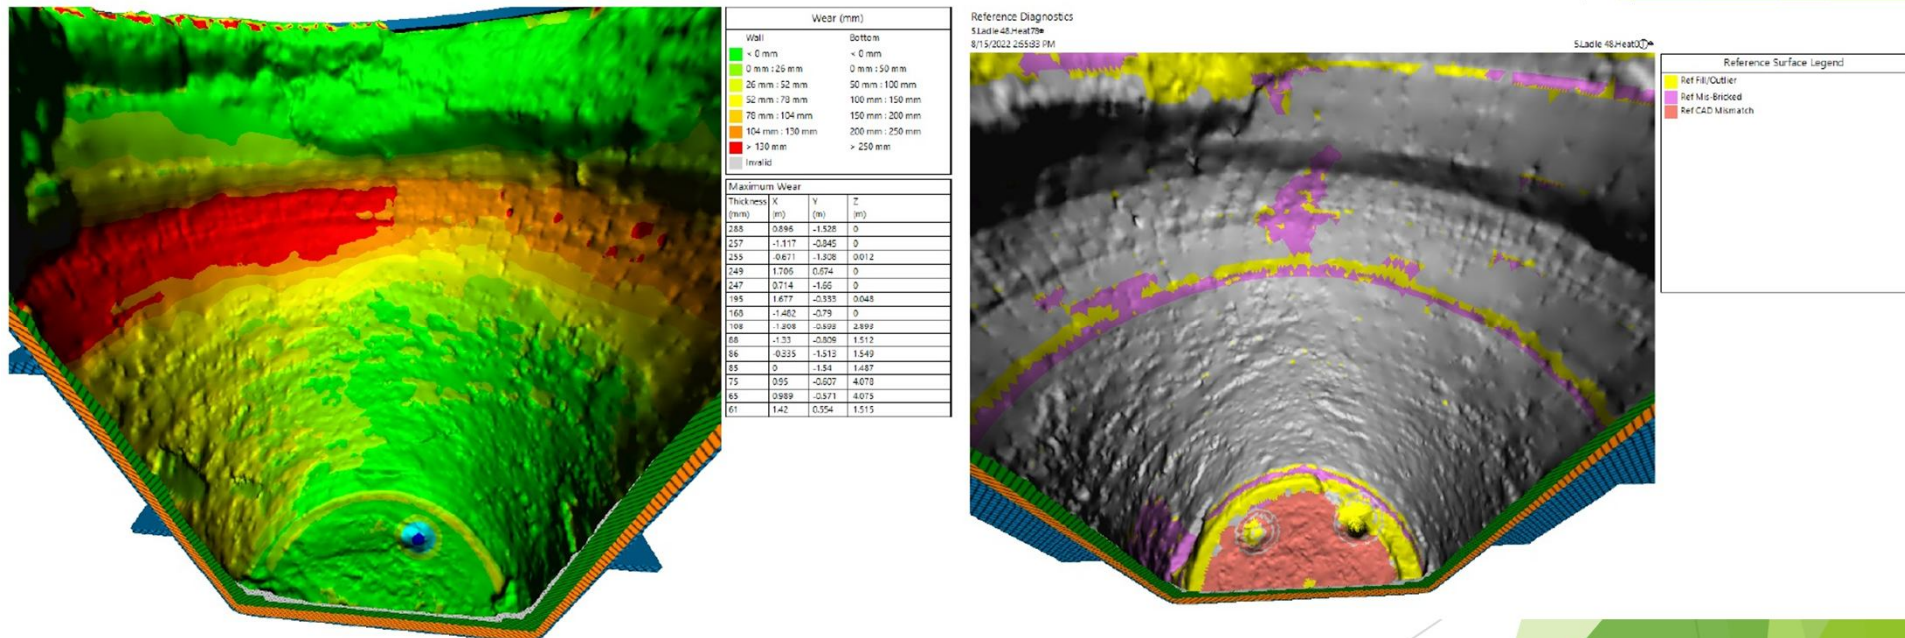
- ▶ Detailed refractory leftover thickness is measured and displayed
