Paper name: **Development of a New Refractory Repair Technology in Hot Blast Stove in pressurized condition at SAIL-IISCO Steel Plant**

SAIL-IISCO STEEL PLANT

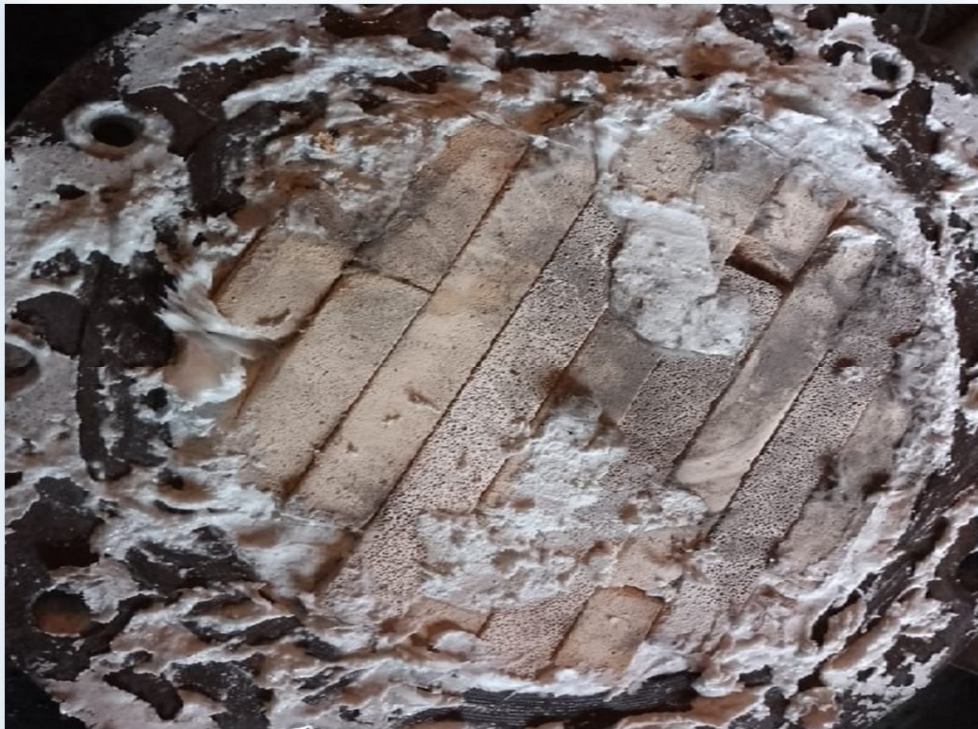
Surface of the brick structure

OFF-LINE TEST

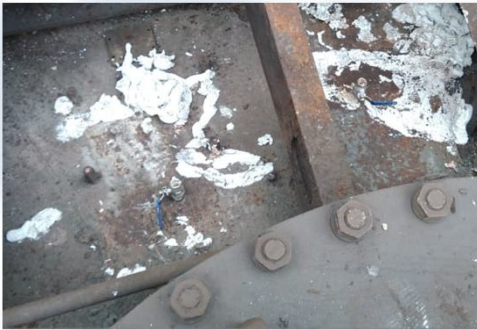
103 °C

- Nozzles and valves fixed by partial drilling and tapping of the shell
- Final drilling done through the valve
- Pumping done at 4 to 5 kg/cm² pressure
- After pumping, valve removed and nozzles were capped.
